IMAGE ARTICLE

Giant Vegetation in a Mitral Prosthetic Valve

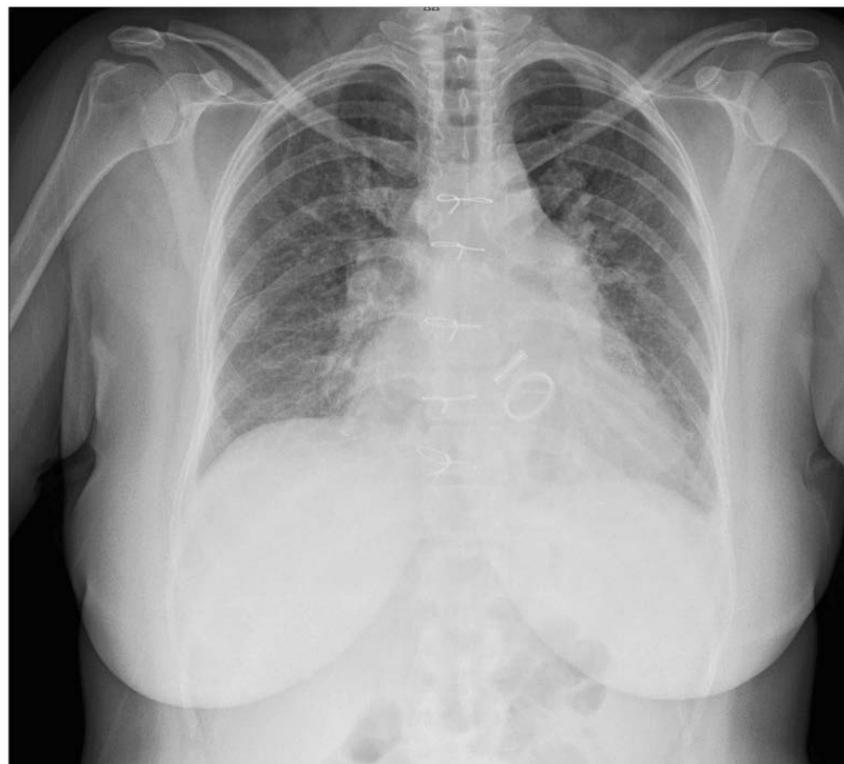
Figure 1: Chest X ray with cardiomegaly and pulmonary veno capillary hypertension.

ripheral edema, normal prosthetic clicks and mitral regurgitant murmur II/IV. The laboratory showed anemia, leucocytosis, high NT-pro BNP and high sensitive C-reactive protein. The chest X-ray with cardio megaly and veno capillary pulmonary hypertension (Figure 1). The transesophageal echocardiogram demonstrated giant vegetation in the
